Customer Release Notes for DP-1006 CRN-0145

ZAP-X® software is a set of major software components. These release notes are for the following version:

- Treatment Planning Software: v1.8.56.
- Treatment Delivery Software: v1.8.53.
- Treatment Delivery Control Service Software: v1.8.53.
- System Database Software: v1.8.19.

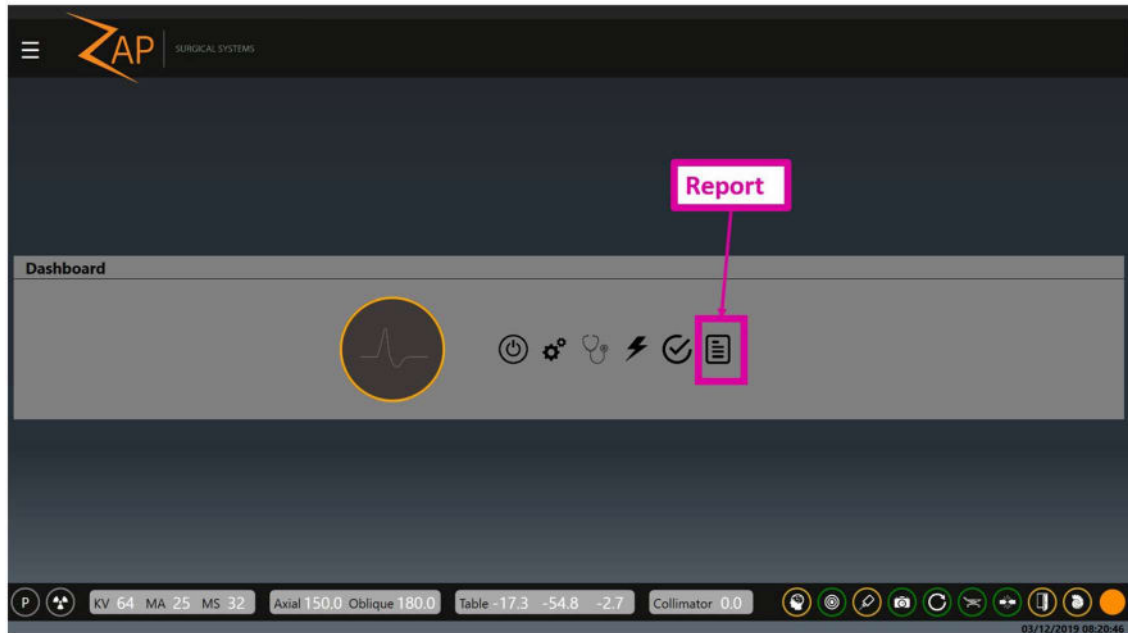
New in DP-1006 CRN-0145 is a system reporting tool that allows the download of KV and MV usage for a user defined time frame. To access this new report, click the Report button on the main dashboard. See Figure 0.1.

Figure 0.1: The Report Button

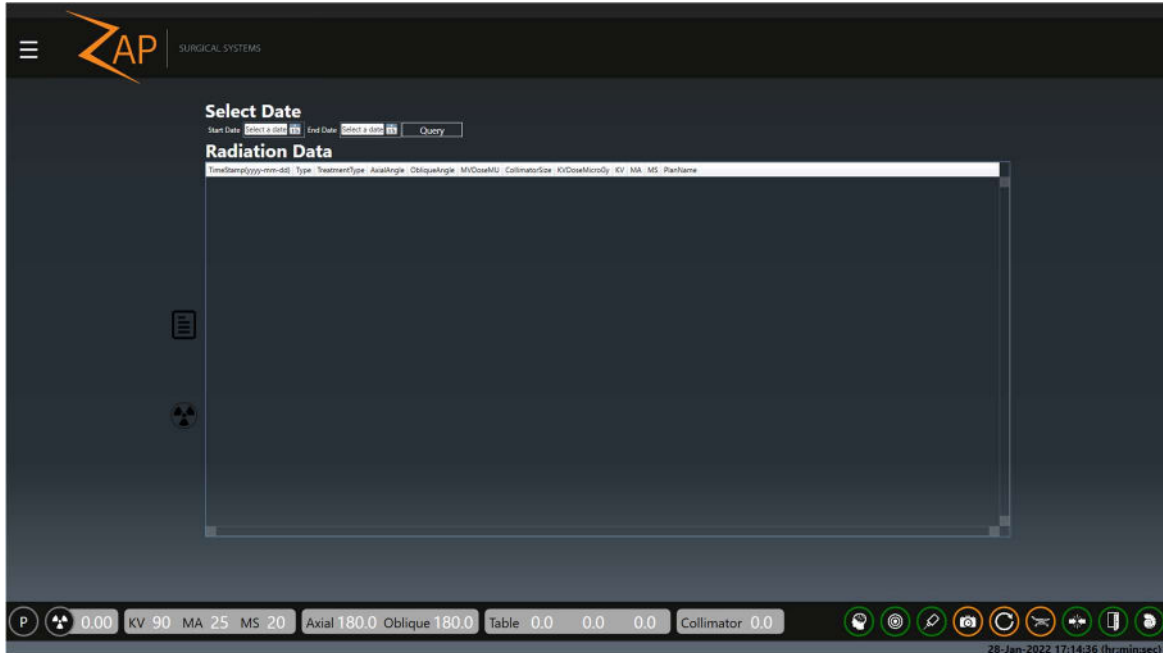
The Load System Report icon opens a report to allow query of KV and MV events between selected dates. Select a start date and end date that you want the data collected from – see Figure 0.3.

Figure 0.3: System Report Options

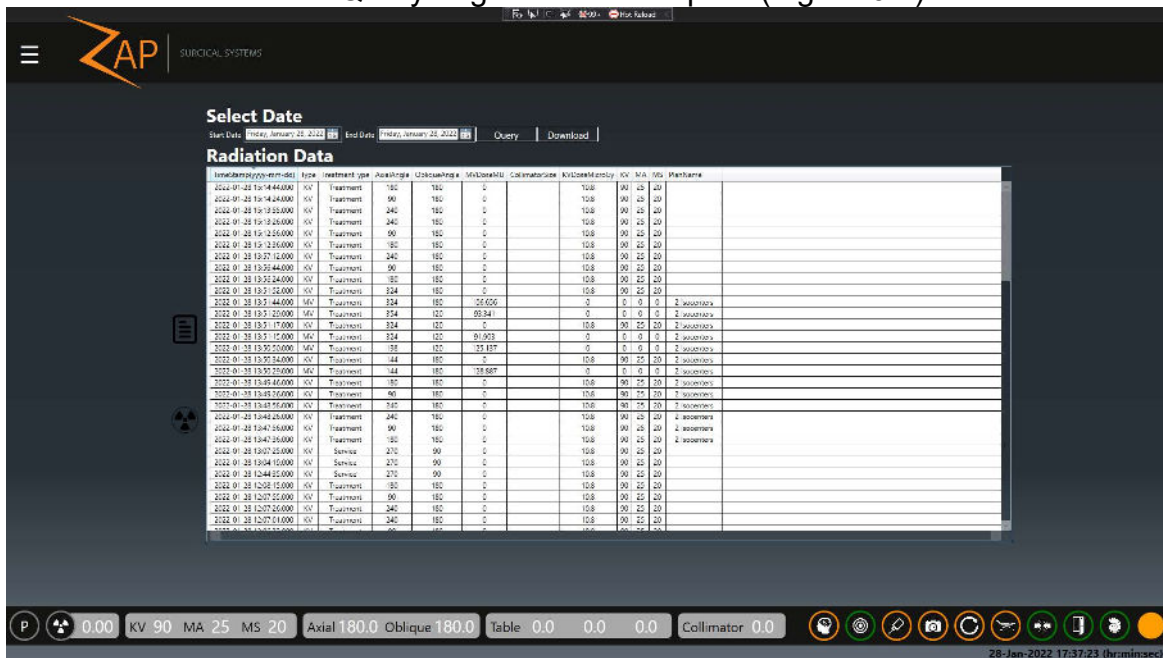
Press Query to generate the report. (Figure 0.4)

Figure 0.4: Report Review and Download

To save a csv file of the data, click Download.
