## **Customer Release Notes for DP-1006 CRN-0151**

## 1. Compatibility

ZAP-X® software is a set of major software components. These release notes are for the following version:

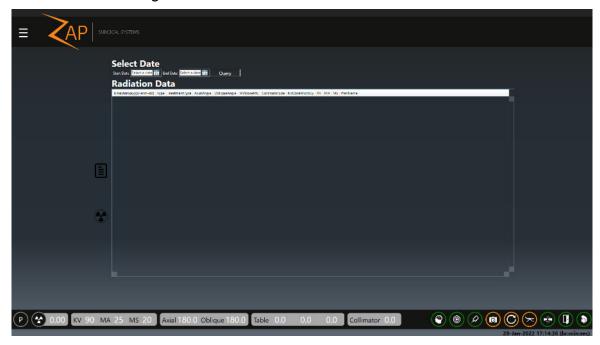
Figure 1.3: System Report Options

The Load System Report icon opens a report to allow query of KV and MV events between selected dates. Select a start date and end date that you want the data collected from – see Figure 1.3.
