Customer Release Notes for DP-1006 CRN-0155

ZAP-X® software is a set of major software components. These release notes are for the following version:

- Treatment Planning Software: v1.8.56.
- Treatment Delivery Software: v1.8.53.
- Treatment Delivery Control Service Software: v1.8.53.
- System Database Software: v1.8.19.

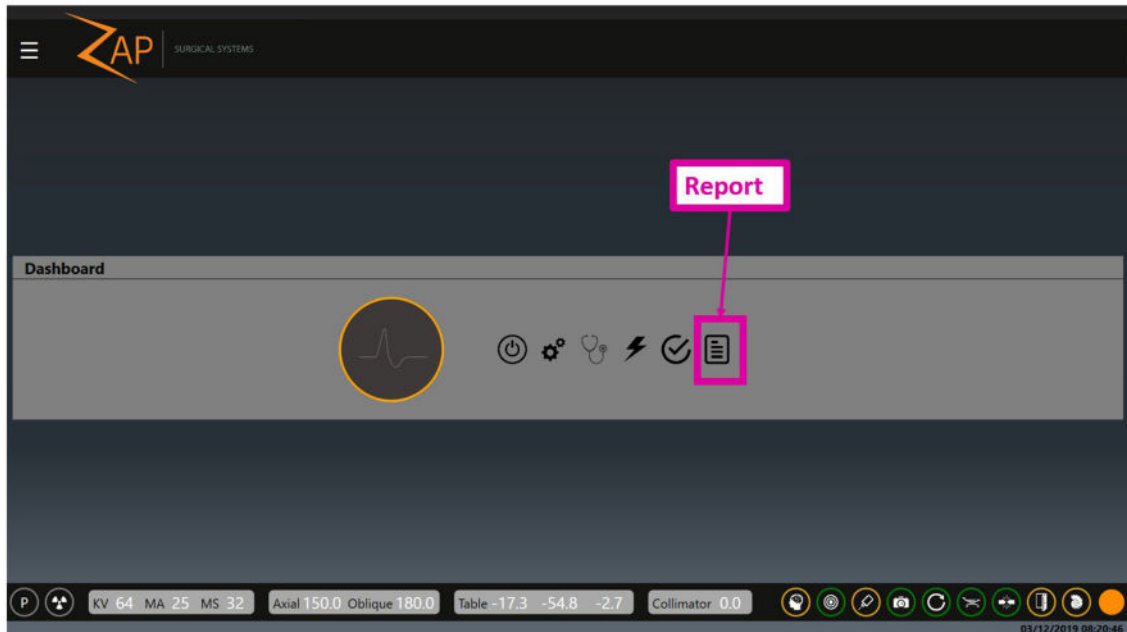
Figure 0.1: The Report Button

New in DP-1006 CRN-0145 is a system reporting tool that allows the download of KV and MV usage for a user defined time frame. To access this new report, click the Report button on the main dashboard. See Figure 0.1.

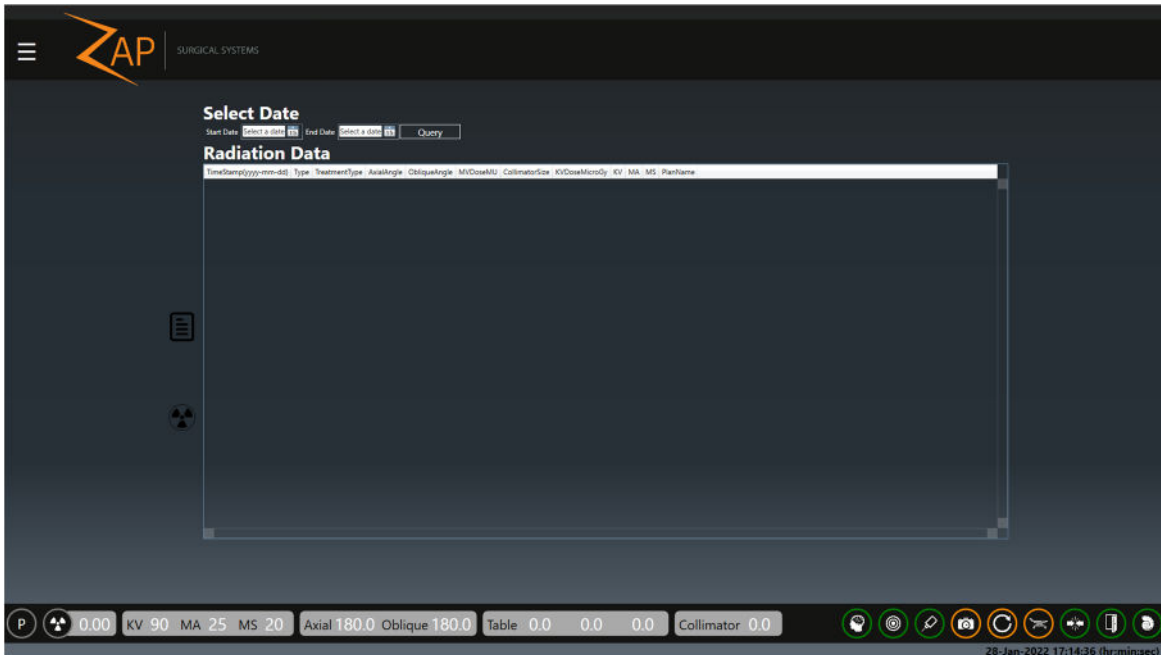
Figure 0.3: System Report Options

The Load System Report icon opens a report to allow query of KV and MV events between selected dates. Select a start date and end date that you want the data collected from – see Figure 0.3.

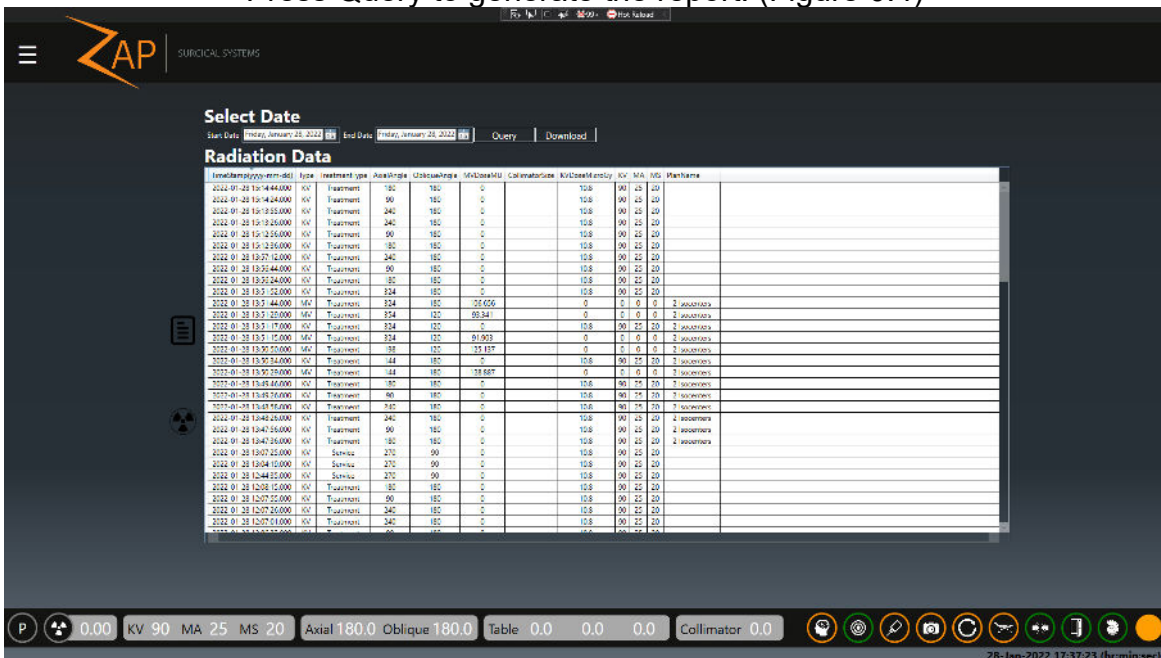
Figure 0.4: Report Review and Download

Press Query to generate the report. (Figure 0.4)

To save a csv file of the data, click Download.
